IN THE UNITED STATES PATENT AND TRADEMARK OFFICE

In re the Application of:)	
)	
PENG LEE and KEVIN SEDDON)	
)	
Serial No.: 10/708,571)	
)	
Filed: March 11, 2004)	
)	
For: NONDESTRUCTIVE RESIDENTIAL)	Attorney Docket No.:
INSPECTION METHOD AND)	1038406-000004
APPARATUS)

AMENDED APPEAL BRIEF

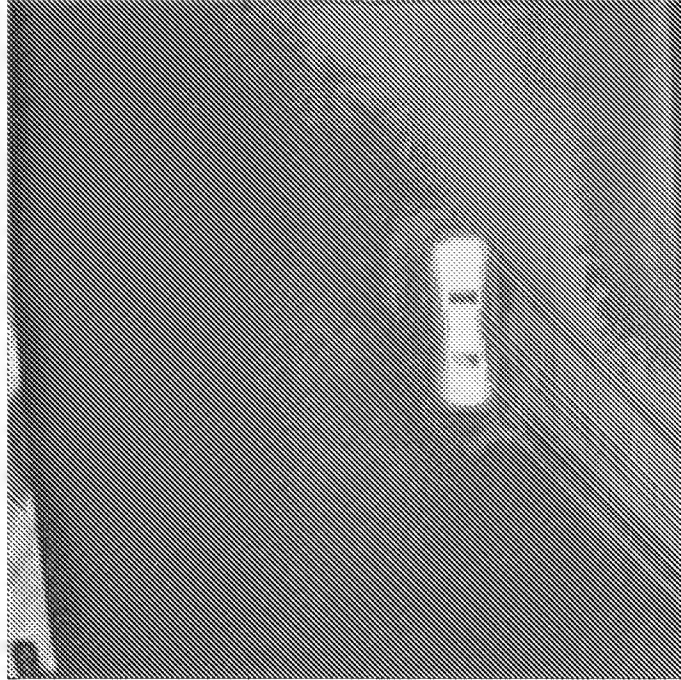
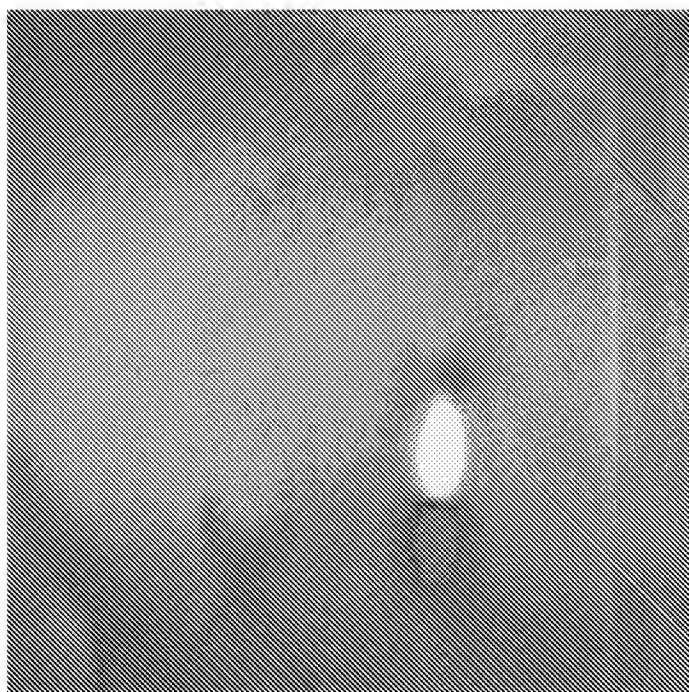
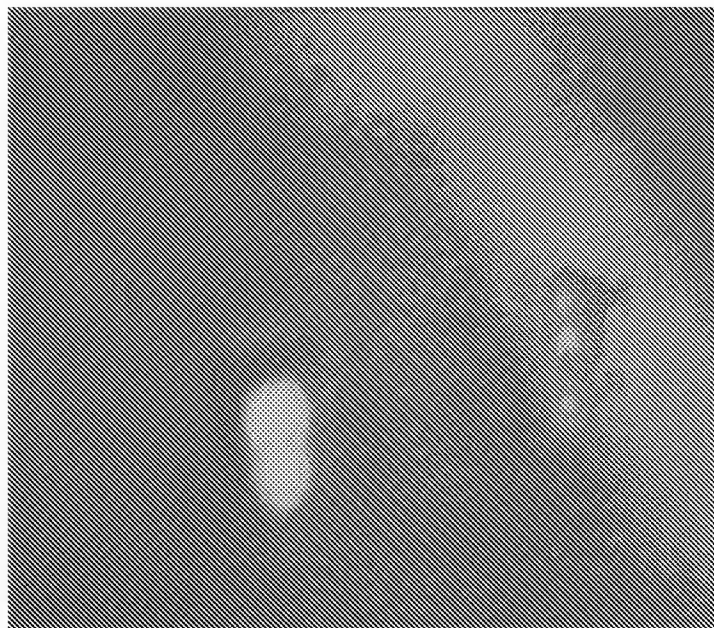
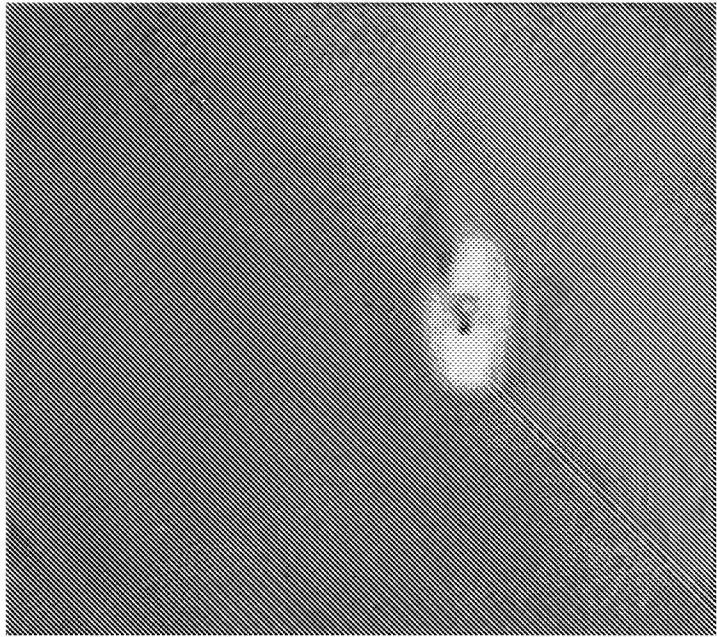
3. In Appendix A, the group of thermal images show surprisingly that, with respect to an electrical outlet both lack of insulation (i.e. dark or cold spots) and electric problems (i.e. white or hot spots) in the outlet can be observed at the same time if the procedural steps set out in the claims are adhered to during the inspection.
